**Regarding: Completion of Phase 8A Base Liner and Leachate Collection System  
Terrapure Environmental Stoney Creek Regional Facility, Stoney Creek, Ontario  
(Certificate of Approval No. A181008)**

## Construction Photographs

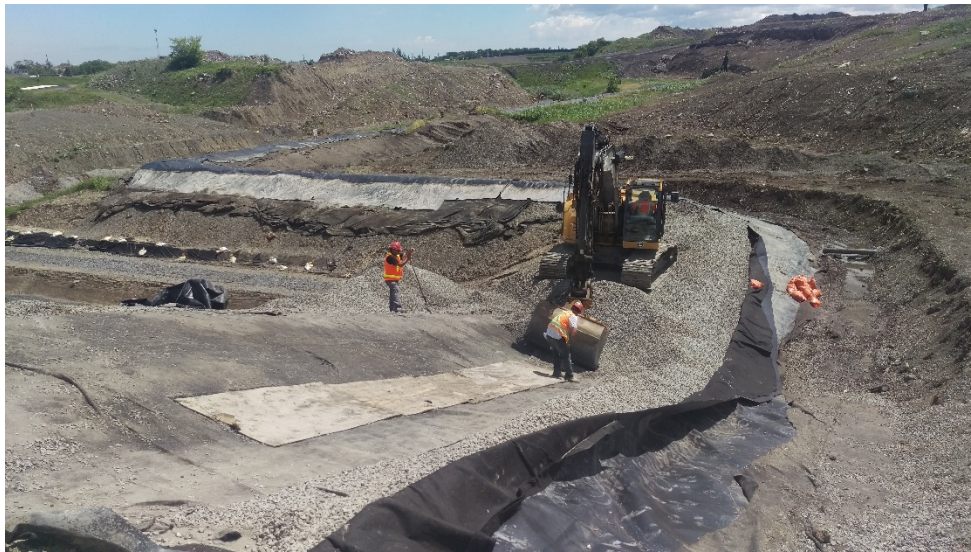
Photo 1 - Removal of the Existing Temporary Berm

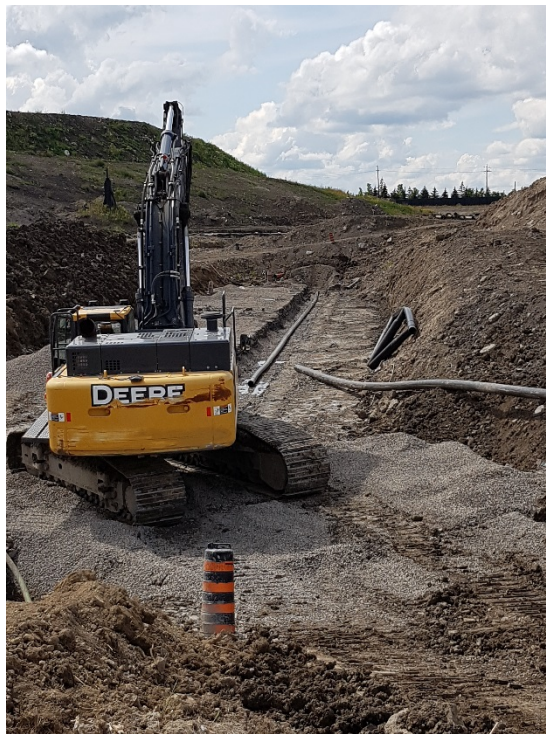
Photo 2 - Construction of Groundwater Collection Trench

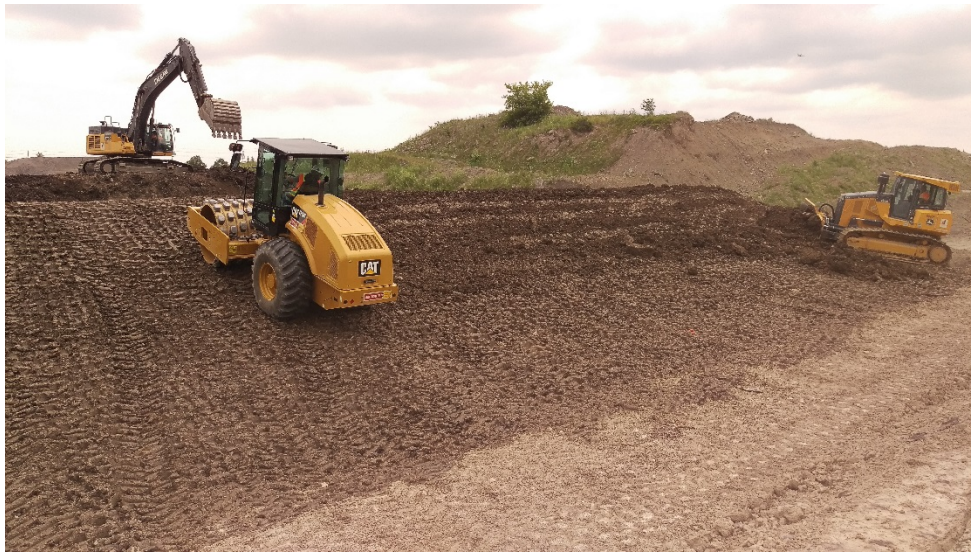
Photo 3 - Construction of the Engineered Fill Sidewall

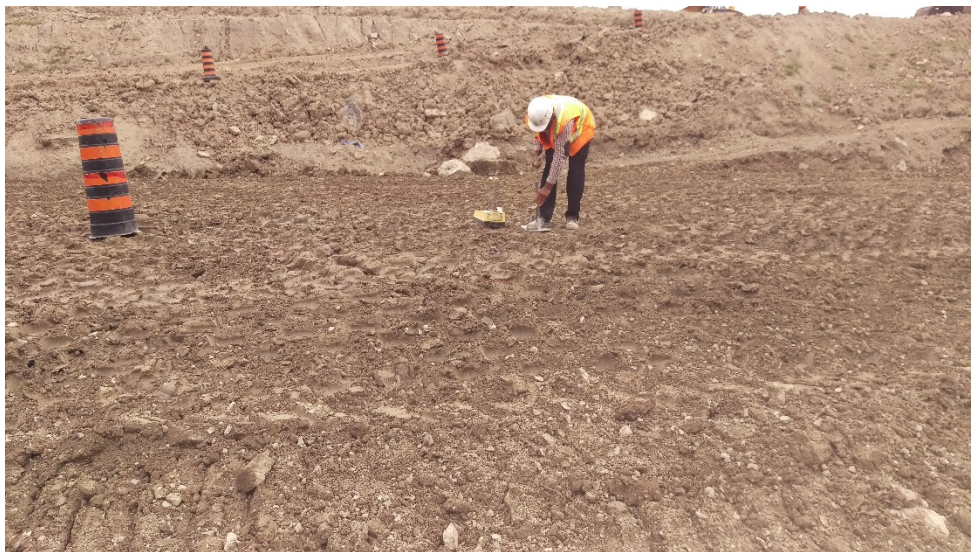
Photo 4 - Conducting In-Situ Compaction Testing of Clay Liner

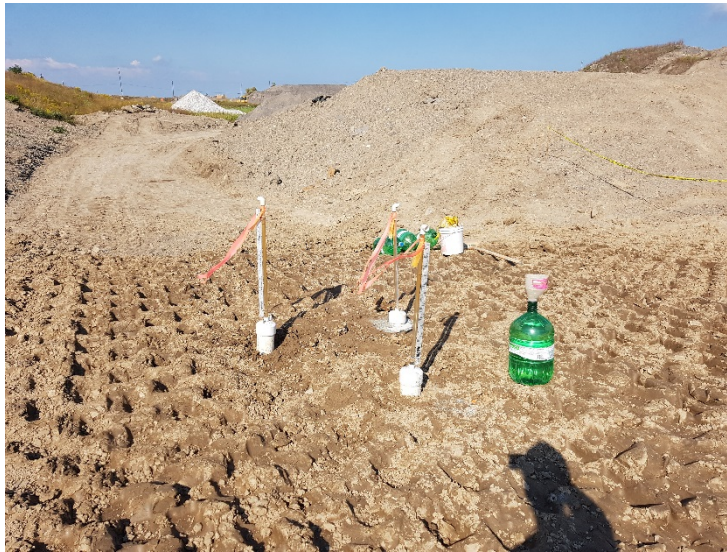
Photo 5 - Conducting In-Situ Hydraulic Conductivity Testing of Clay Liner

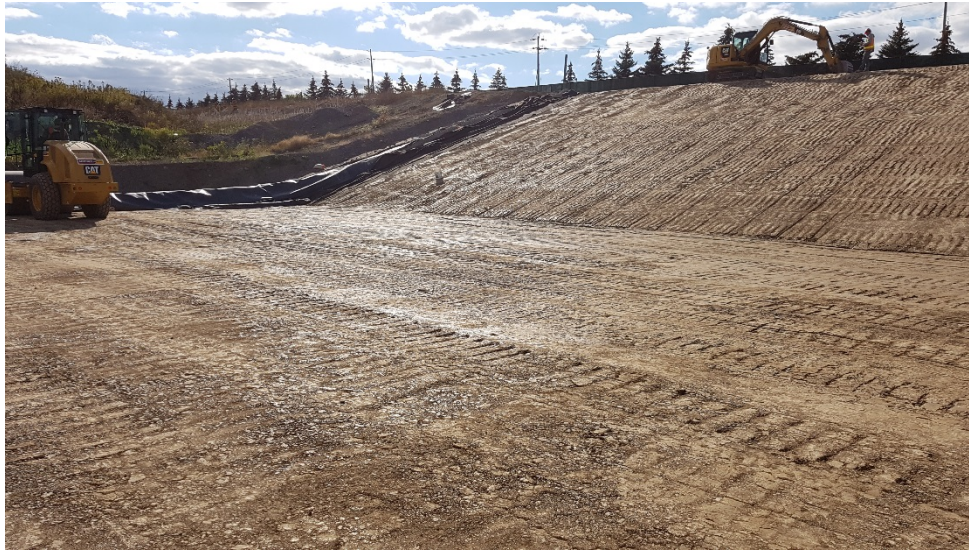
Photo 6 - Smooth Rolling the Final Lift of the Clay Liner

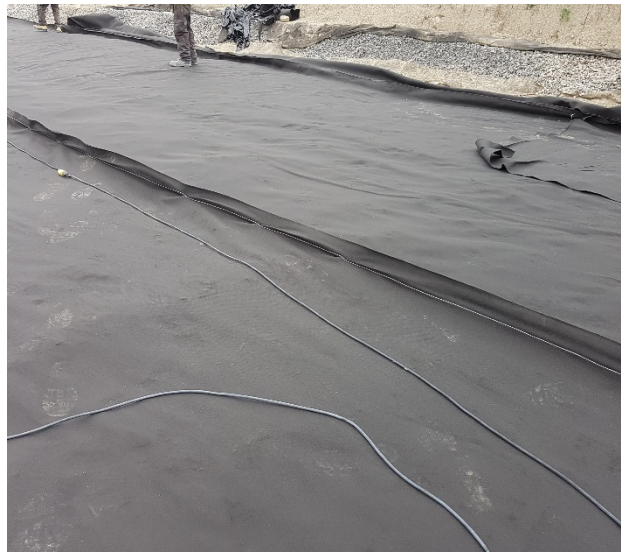
Photo 7 - Seaming of Geotextile

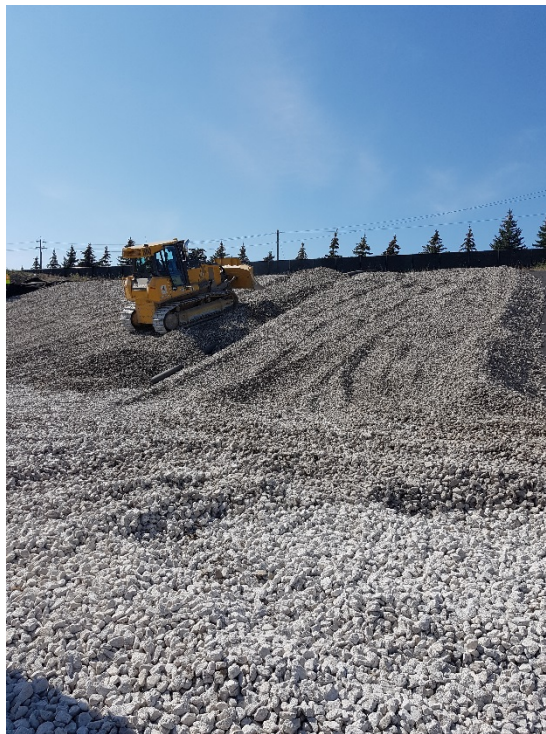
Photo 8 - Placement of Clear Stone for the Hydraulic Control Layer

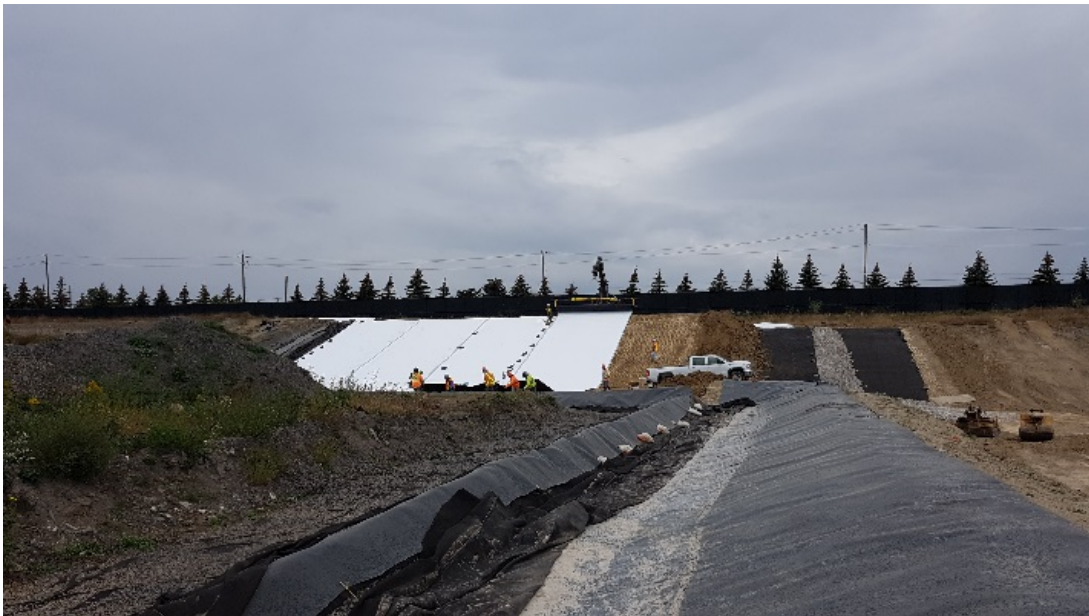
Photo 9 - Deploying Geomembrane on the Sidewall

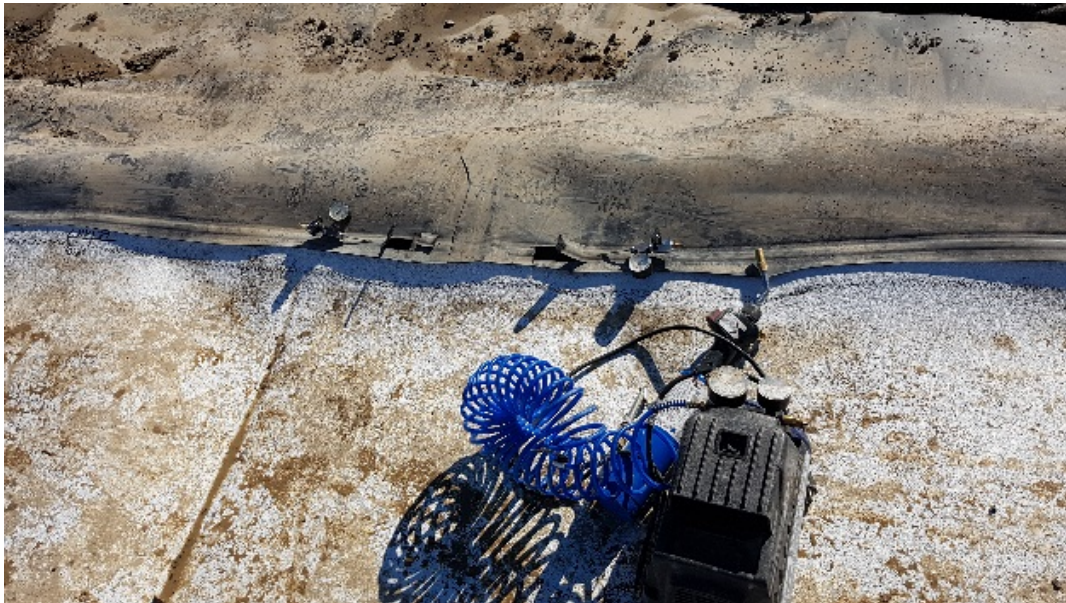
Photo 10 - Air Testing Welded Geomembrane Seam

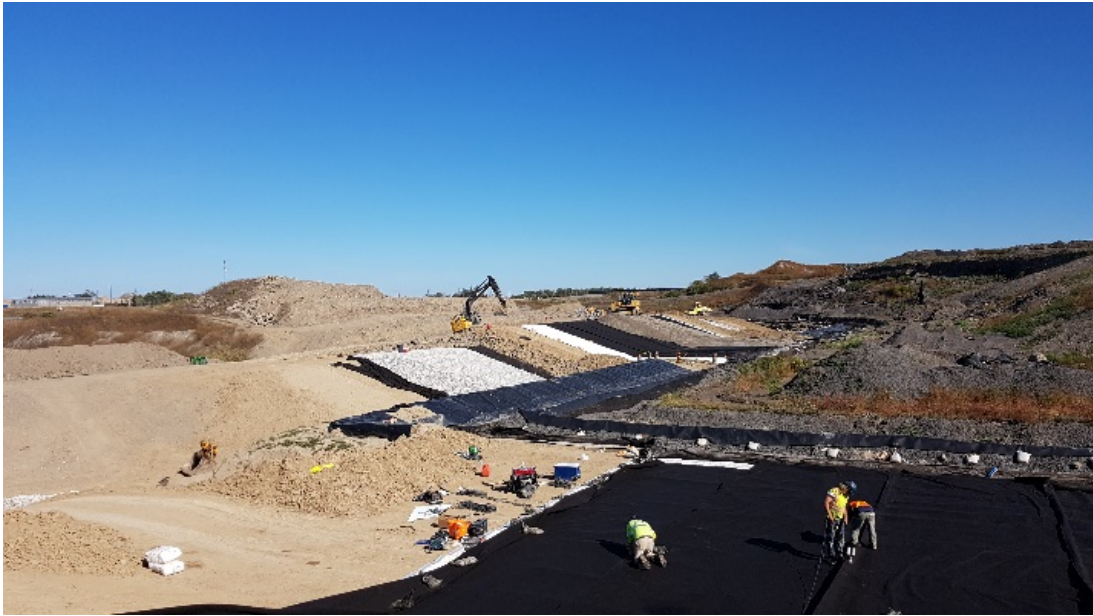
Photo 11 - Staged Construction of Base Liner Components

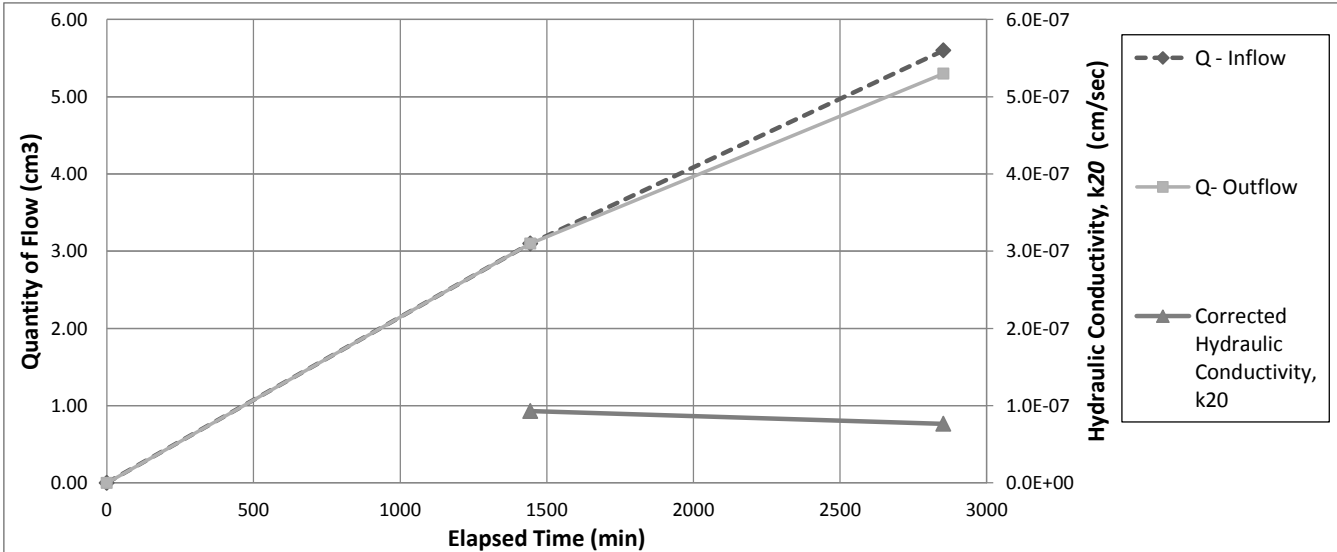
**REMARKS:** Sample remolded to approx. 98% of SPMD  
 Max. 5\*10<sup>-8</sup> cm/ sec. Doesn't meet the specification
