**Regarding: Completion of Phase 8A Base Liner and Leachate Collection System  
Terrapure Environmental Stoney Creek Regional Facility, Stoney Creek, Ontario  
(Certificate of Approval No. A181008)**

## Construction Photographs

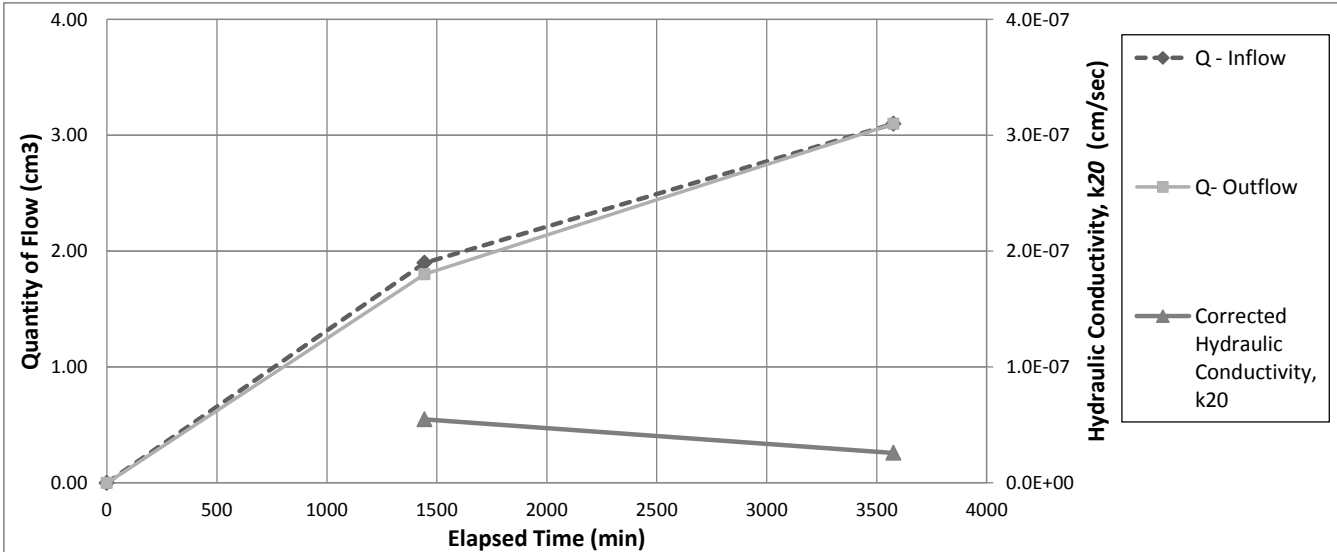
Permeation Condition	
Cell Pressure, kPa	400.0
Head Pressure, kPa	387.5
Back Pressure, kPa	377.5
B - Value	0.98
Effective Consolidation Pressure, kPa	20.00
Volume under Steady Flow, cm <sup>3</sup>	3.1
Hydraulic Gradient, <i>i</i>	19.0
<b>Hydraulic Conductivity, <i>k</i><sub>20</sub>, cm/sec</b>	<b>4.0E-08</b>

**REMARKS:** Sample remolded to approx. 98% of SPMD  
 Max. 5\*10-8 cm/ sec. Meets the specification

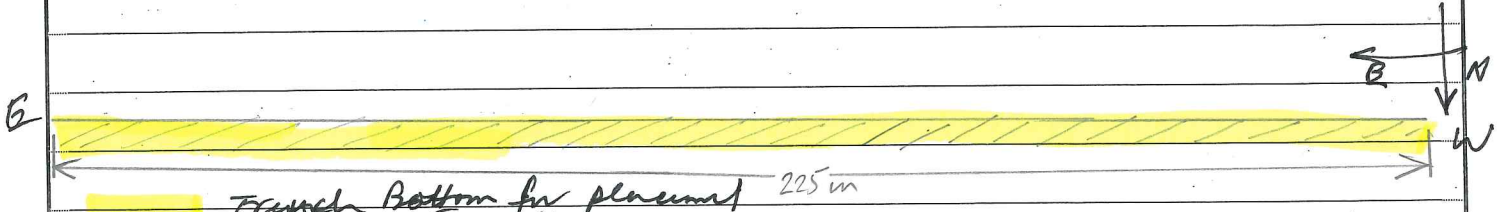
- 1) Areas inspected: About 225m long in East west direction.
- 2) The depth of Bed of Trench: About 1.2m to 1.4m bgs.
- 3) The contractor placed gr A.
- 4) Compaction was performed by 24" Dredal Tempson plate.
- 5) Nuclear Density gauge had been carried out to check the compaction.
- 6) Test results showed 99% to 100% SPDD, which met the project specifications.

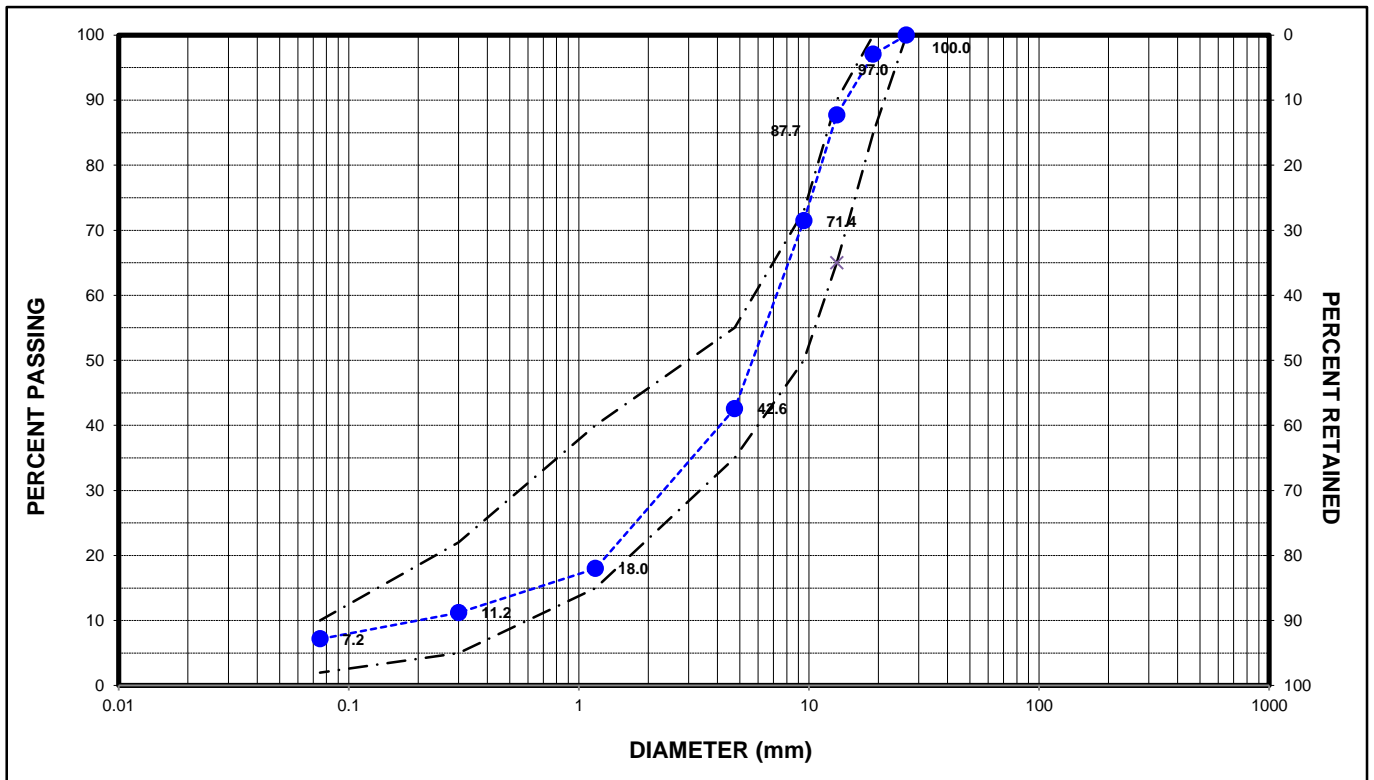
**Remarks:** Granular A (Composite mixture of crushed limestone, shale, brick fragments and gravel)  
 Sample meets the OPSS specifications for: GRANULAR A - SIEVE ANALYSIS (QUARRY)

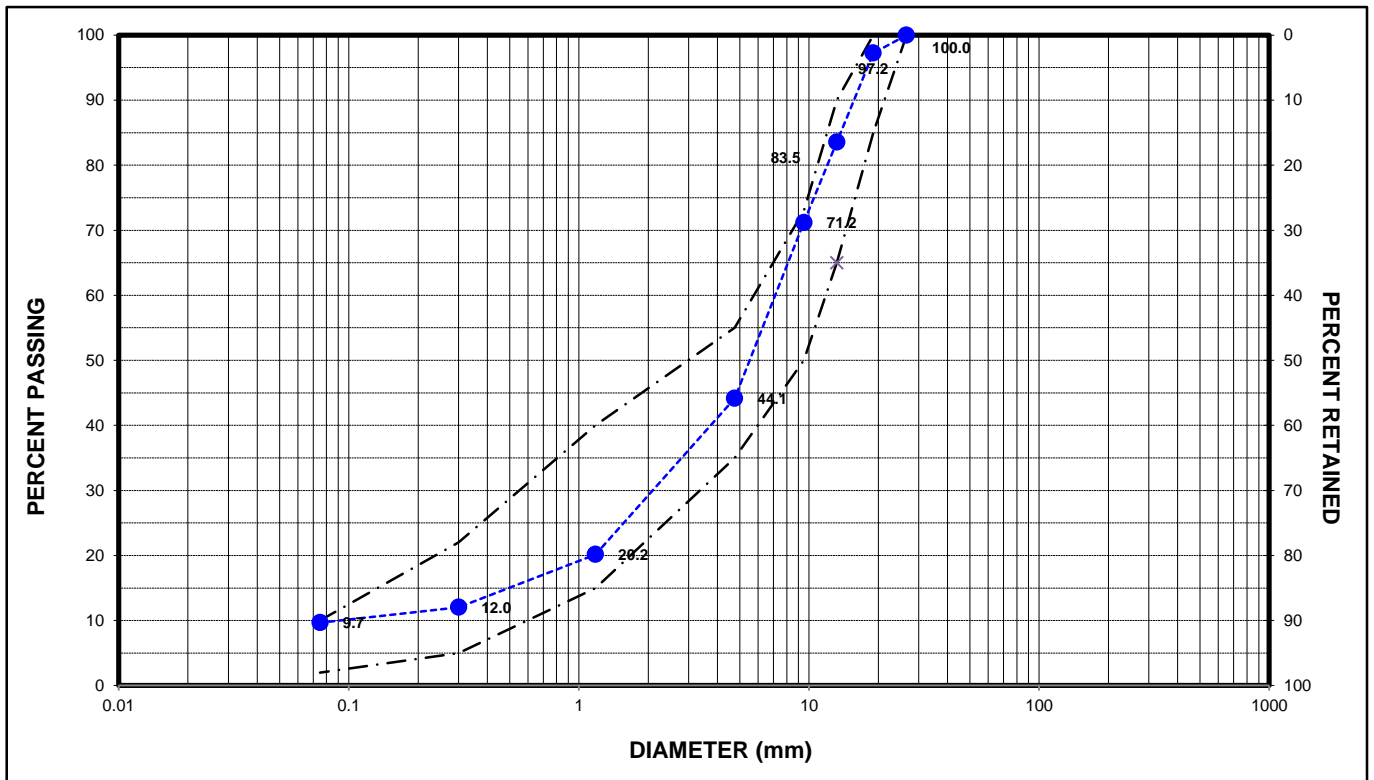
**Remarks:** Granular A (Composite mixture of crushed limestone, shale, brick fragments and gravel)  
 Sample meets the OPSS specifications for: GRANULAR A - SIEVE ANALYSIS (QUARRY)

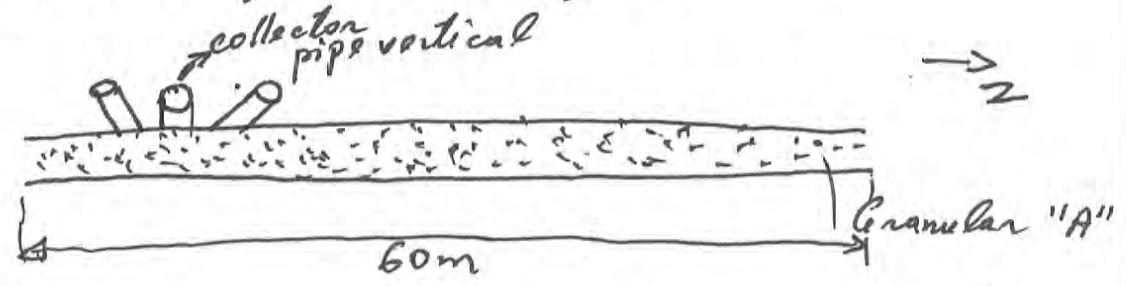
The above noted site was visited by GHD representative as requested. The purpose of the visit was to conduct the compaction test within the Groundwater collection trench. The contractor used the Granular "A" material, mixt with crushed limestone, shale and gravel.

After using a nuclear density gauge, all tests results showed 98% to 100% spmBS, which met the project specifications. (see sketch below for location)

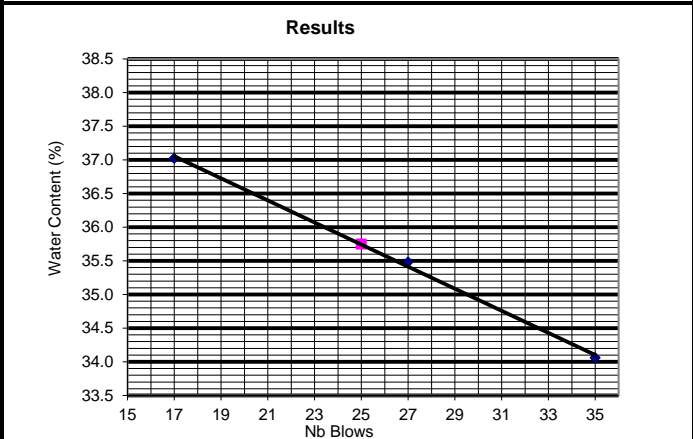
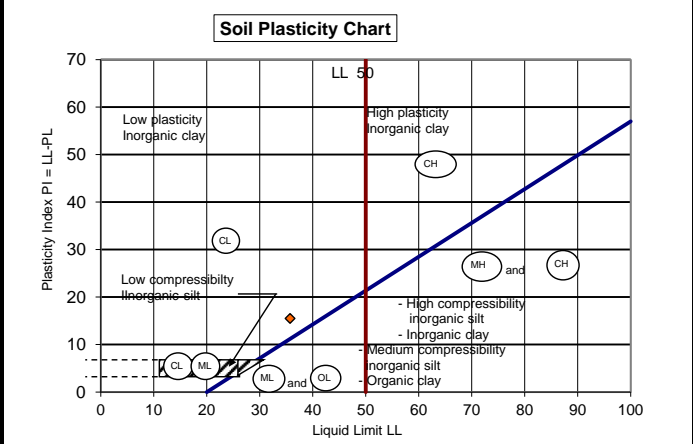
**Remarks:** The clay sample meets the project specifications for clay liner material (Plasticity Index: 30 > PI > 12)  
Section 31 05 21

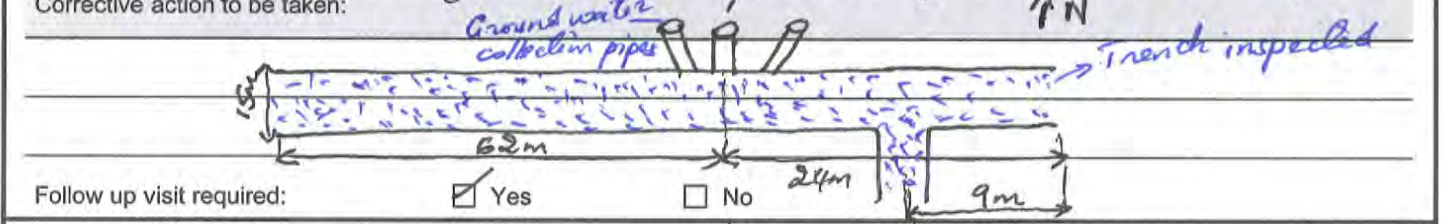
It's important to notice that, before placement of Granular "A" materials, the contractor has placed the following items:

- Groundwater collection pipes
- 19mm clear stone over the pipe (one layer of 300mm)
- Type B geotextile (see attached pictures for more details).

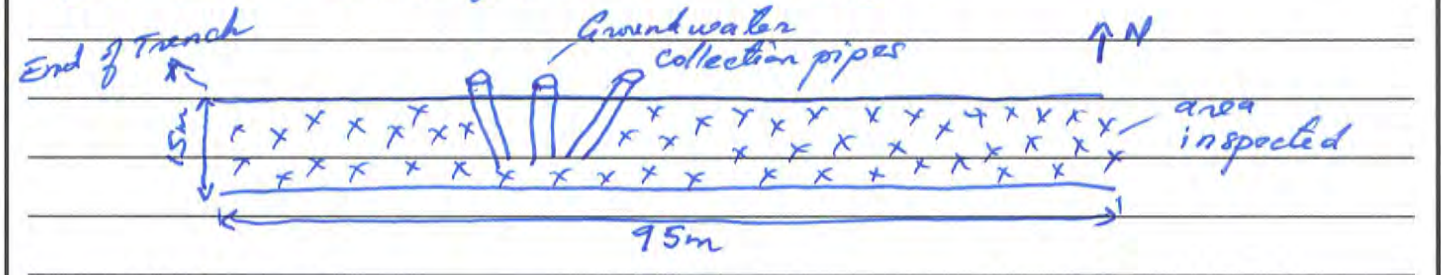
The above noted site was visited by GHD representative as required. The purpose of the visit was to conduct the compaction test on the excavated materials (silty clay with crushed & natural gravel), being used as Engineered fill for backfilling the trench. After using a nuclear density gauge, all tests results showed 95% to 96% SPMDD, which met the project specifications. (see sketch below for more details).

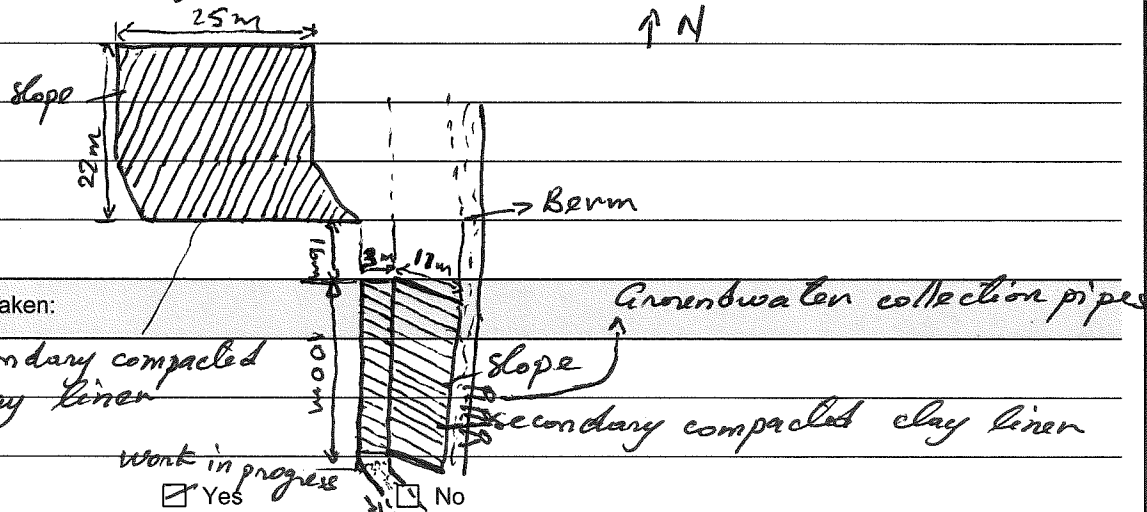
The above noted site was visited by GHD representative as requested. The purpose of the visit was to conduct the compaction test on the silty clay trace sand & gravel materials, being used as secondary compacted clay liner for raising the trench grades. After using a nuclear density gauge, all test results showed 98% to 99% spmDD, which met the project specifications. (See sketch below for more details).

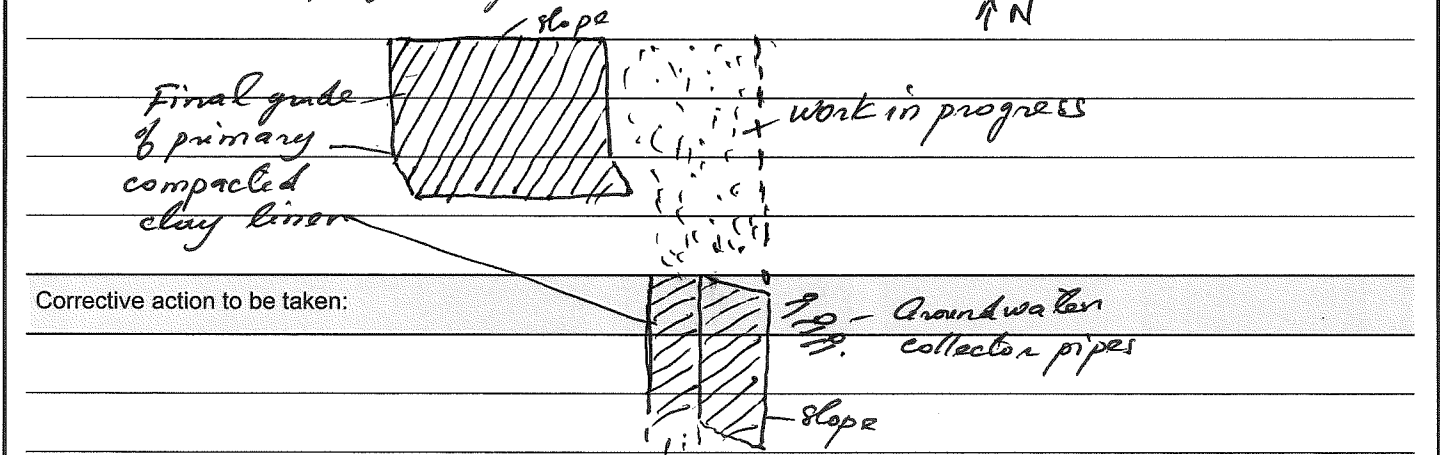
The above noted site was visited by GHD representative as requested. The purpose of the visit was to conduct the compaction test on the silty clay loose sand & gravel material, being as final grade of primary compacted clay liner construction. The compaction was performed by the medium size sheepfoot roller. After using a nuclear density gauge, all test results showed 98% to 100% SPMSD, which met the project specifications.

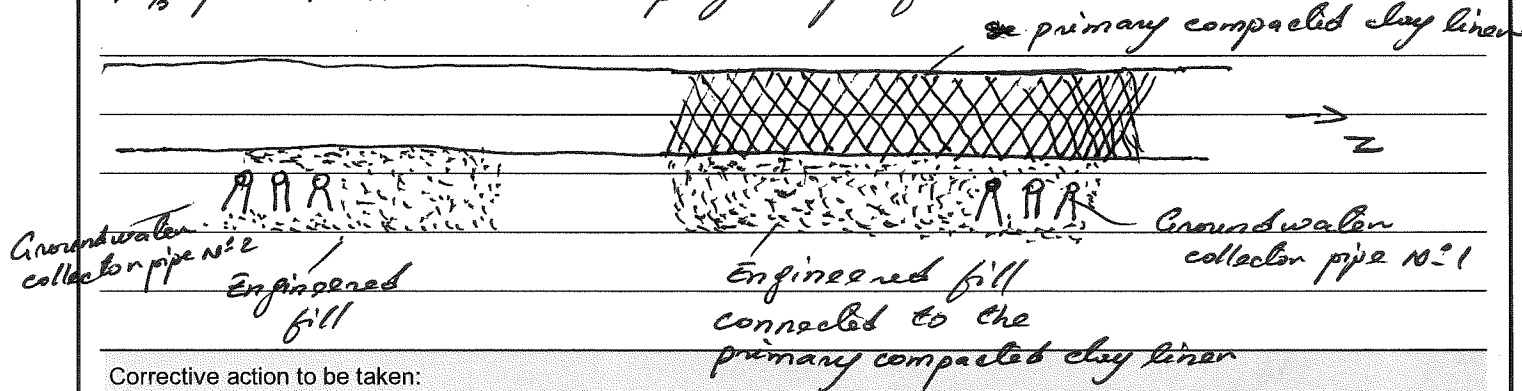
The above noted site was visited by GHD representative as requested. The purpose of the visit was to conduct the compaction test on the silty clay with crushed and natural gravel, being used as engineered fill for backfilling the trench within two areas (see sketch below). After using a nuclear density gauge, all test results showed 95% to 98% SPMAS, which met the project specifications.

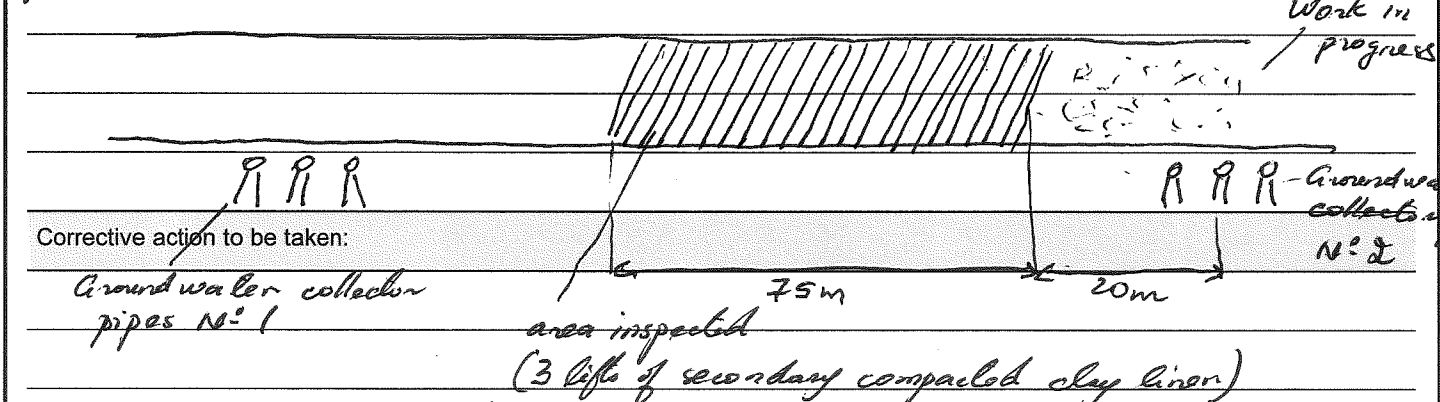
The purpose of the visit was to conduct the compaction test on the silty clay brace sand & gravel material being used as secondary compacted clay liner (see sketch below for more details). The compaction was performed by the medium size sheepsfoot roller, and all test results showed 98% to 100% SPMDA, which met the project specifications. The contractor has made some efforts for picking-up the rocks, and each lift was watered before the placement of successive lifts.

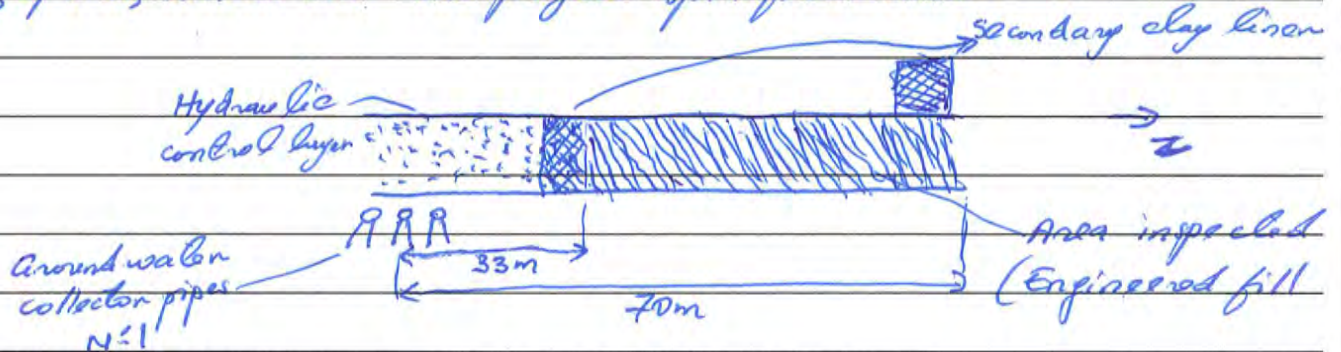
The above noted site was visited by GHD representative as requested. The purpose of the visit was to conduct the compaction test on the excavated material (silty clay with crushed & natural gravel) being used as Engineered fill for backfilling the trench (North side). After using a nuclear density gauge, all test results showed 96% to 99% SPMDD, which met the project specifications.

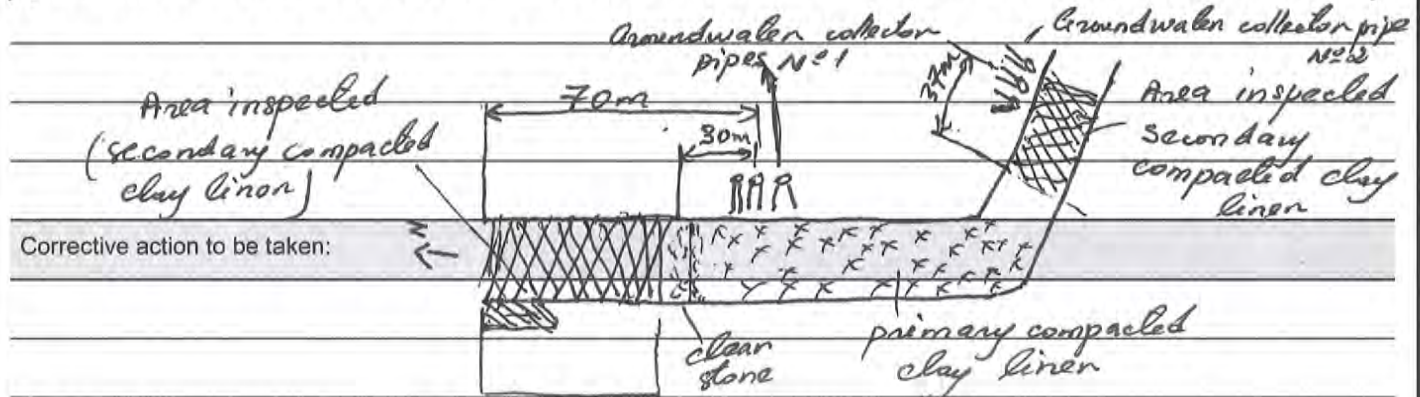
The above noted site was visited by GHD representative as requested. The purpose of the visit was to conduct the compaction test on the silty clay trace sand & gravel material, being used for secondary compacted clay liner construction. The compaction was performed by the medium size sheepfoot roller, and all test results showed 98% to 100% spmdd, which met the projects specifications. The contractor has made some efforts for picking-up the roots. (for more details about the locations see sketch below and some photos)

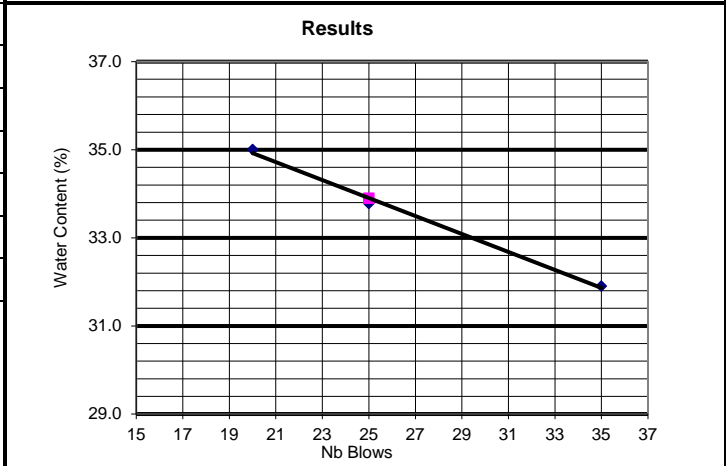
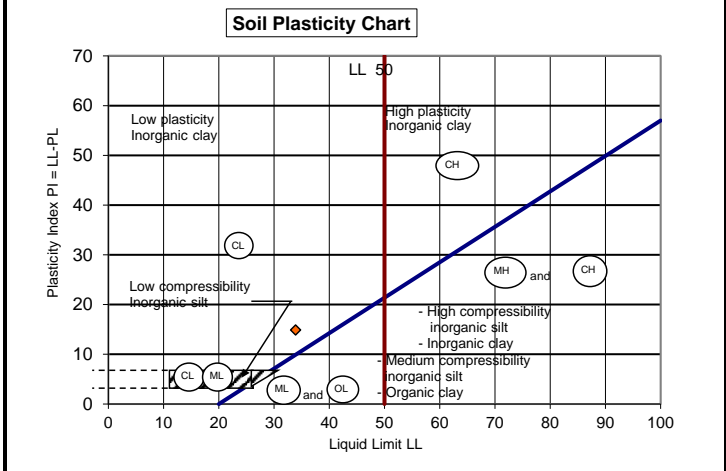
Liquid Limit (LL)	Plastic Limit (PL)	Plasticity Index (PI)	Natural Water Content W <sup>n</sup>
34	19	15	21

**Remarks:** The material meets the project specifications

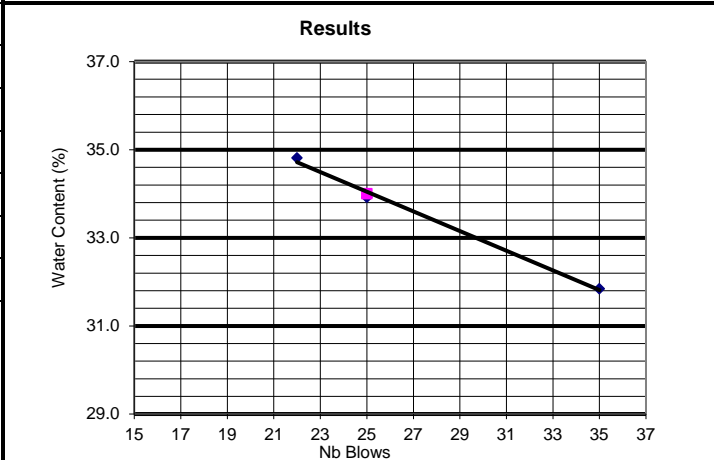
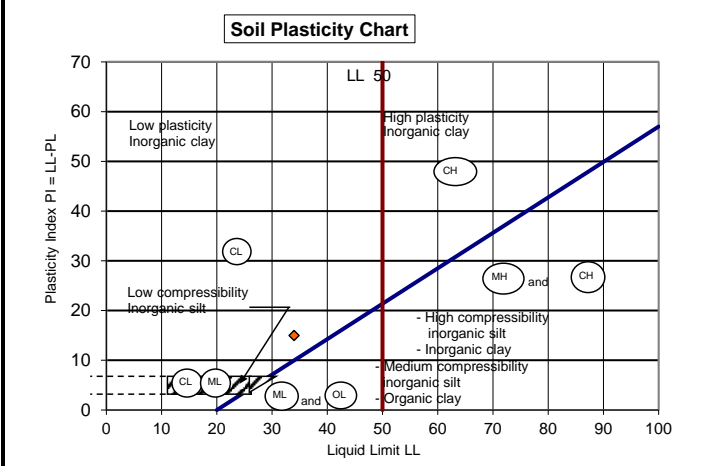
Liquid Limit (LL)	Plastic Limit (PL)	Plasticity Index (PI)	Natural Water Content W <sup>n</sup>
34	19	15	18

**Remarks:** The material meets the project specifications

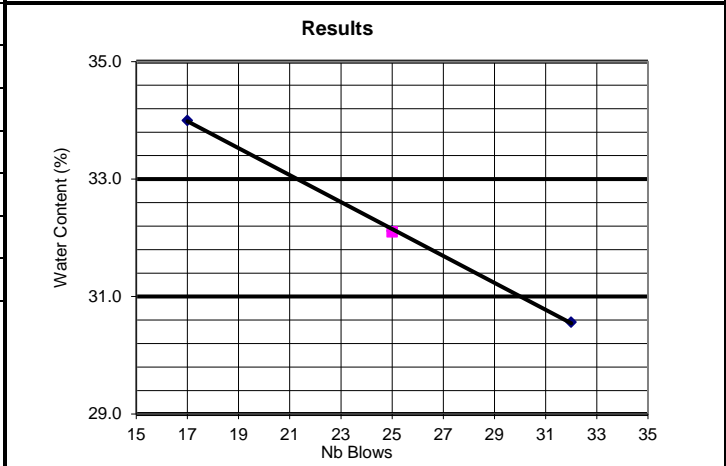
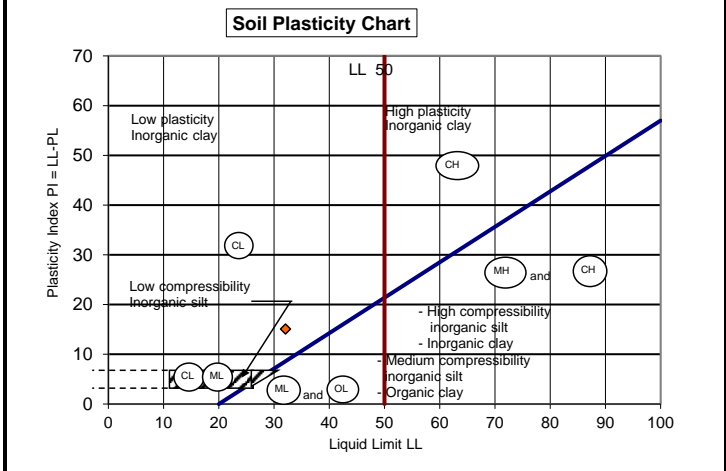
Liquid Limit (LL)	Plastic Limit (PL)	Plasticity Index (PI)	Natural Water Content W <sup>n</sup>
32	17	15	18

**Remarks:** The material meets the project specifications

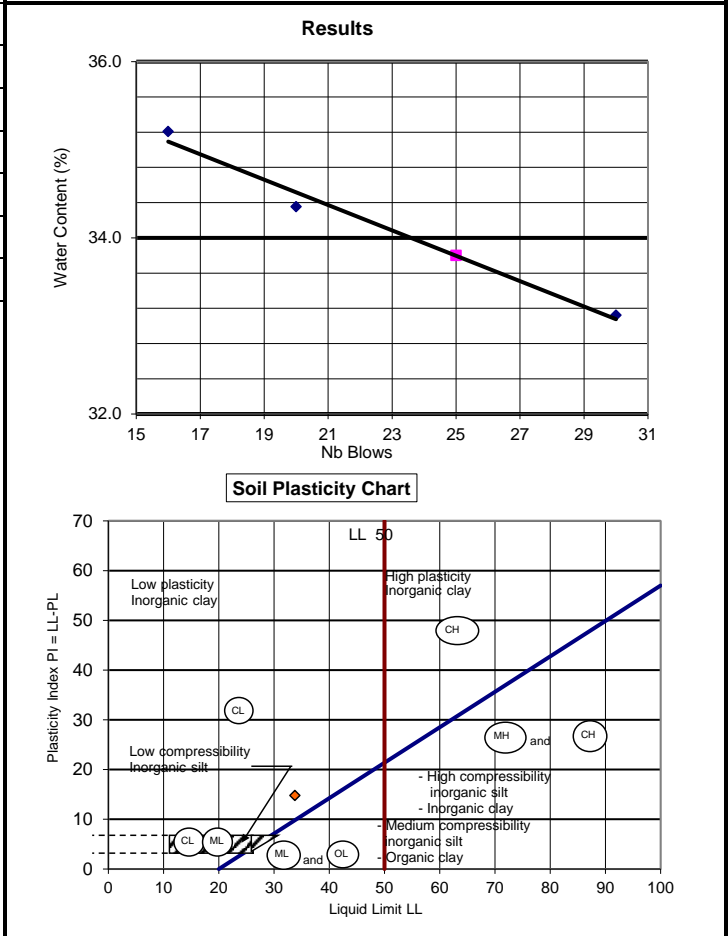
**Remarks:** The material meets the project specifications

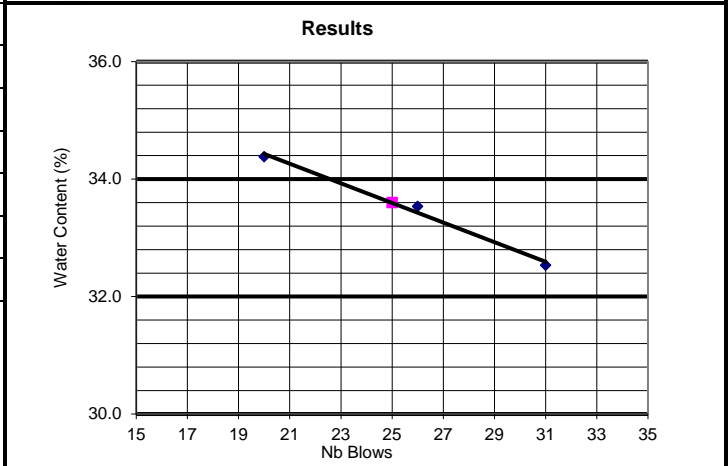
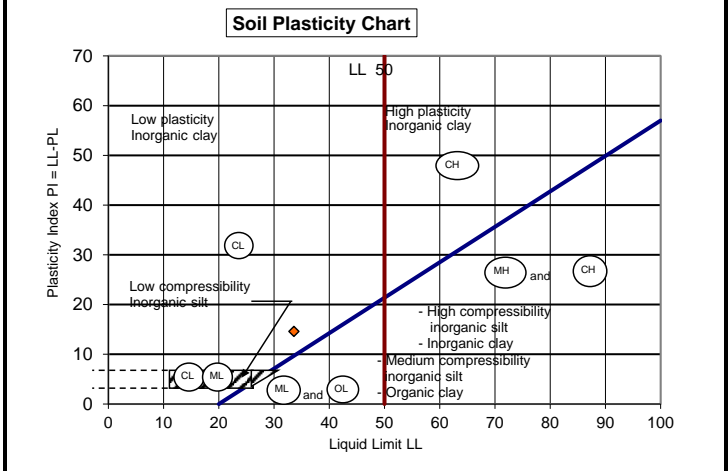
Liquid Limit (LL)	Plastic Limit (PL)	Plasticity Index (PI)	Natural Water Content W <sup>n</sup>
34	19	15	15

**Remarks:** The material meets the project specifications

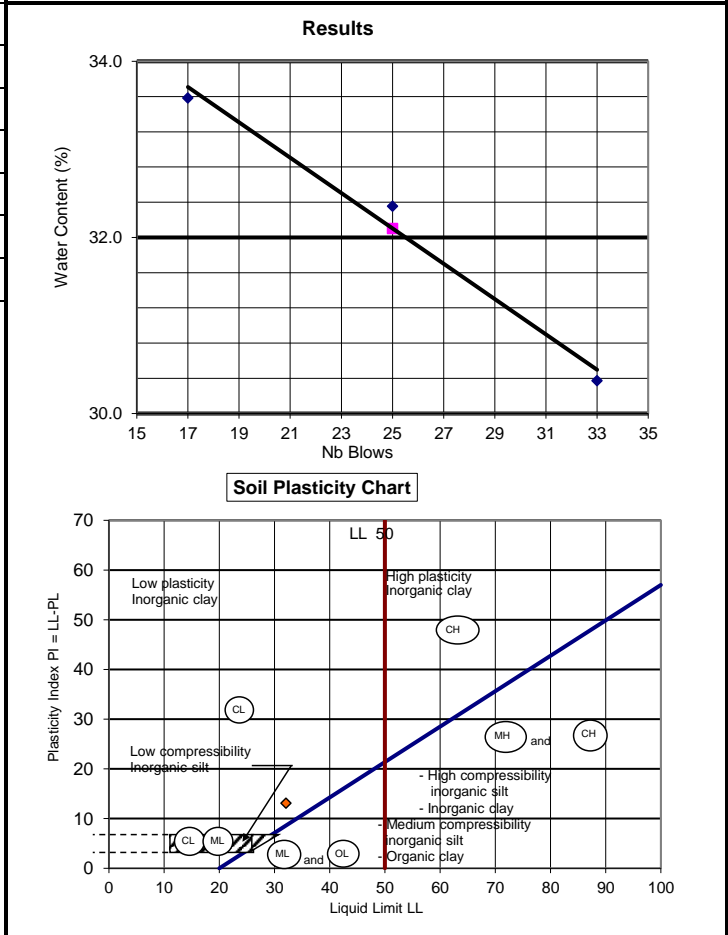
Liquid Limit (LL)	Plastic Limit (PL)	Plasticity Index (PI)	Natural Water Content W <sup>n</sup>
32	19	13	19

**Remarks:** The material meets the project specifications

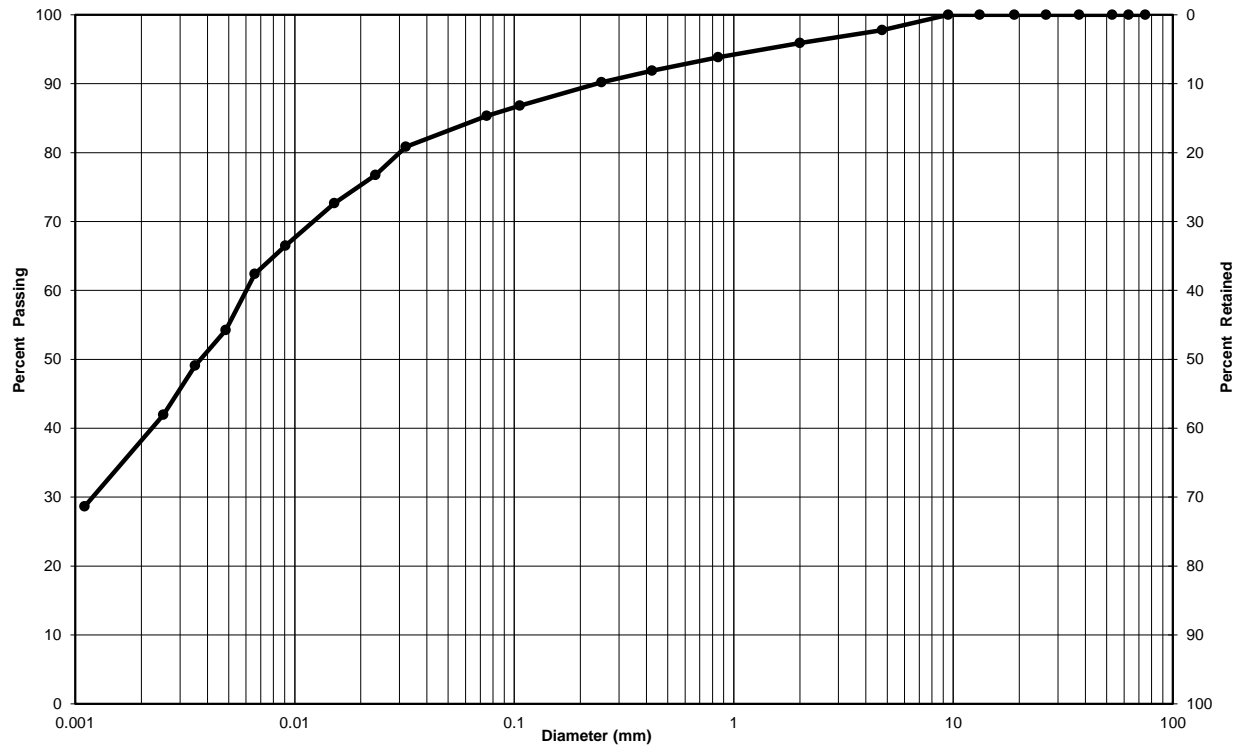
<b>Client:</b>	Terrapure Environmental	<b>Lab No.:</b>	WLB 1329-1
<b>Project, Site:</b>	Stoney Creek Landfill 65 Green Mountain Road West, Hamilton, Ontario	<b>Project No.:</b>	11103232
<b>Borehole No.:</b>		<b>Sample No.:</b>	1A
<b>Depth:</b>		<b>Enclosure:</b>	-

Soil Description	Gravel (%)	Sand (%)	Clay & Silt (%)
Lean clay with sand (CL)	2	13	85
Clay-size particles (<0.002 mm):	37 %

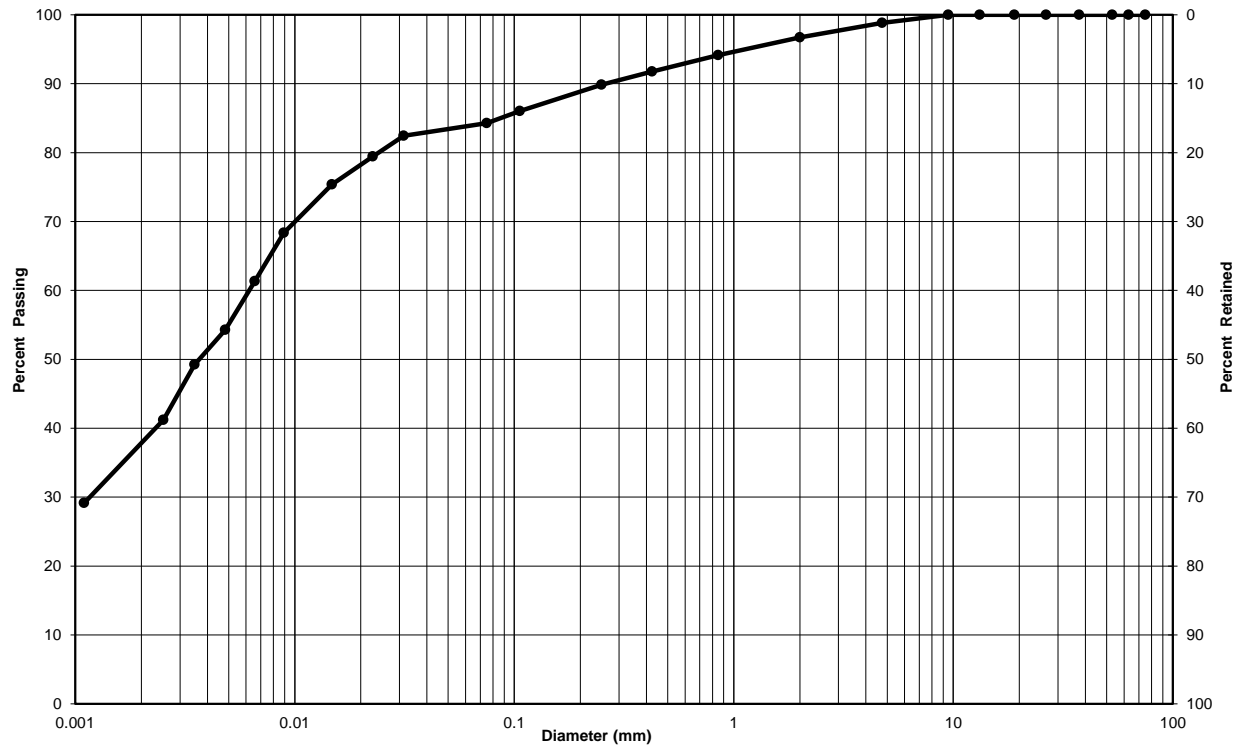
<b>Client:</b> Terrapure Environmental	<b>Lab No.:</b> WLB 1329-2
<b>Project, Site:</b> Stoney Creek Landfill 65 Green Mountain Road West, Hamilton, Ontario	<b>Project No.:</b> 11103232
<b>Borehole No.:</b> _____	<b>Sample No.:</b> 2A
<b>Depth:</b> _____	<b>Enclosure:</b> -

Soil Description	Gravel (%)	Sand (%)	Clay & Silt (%)
Lean clay with sand (CL)	1	15	84
Clay-size particles (<0.002 mm):	37 %

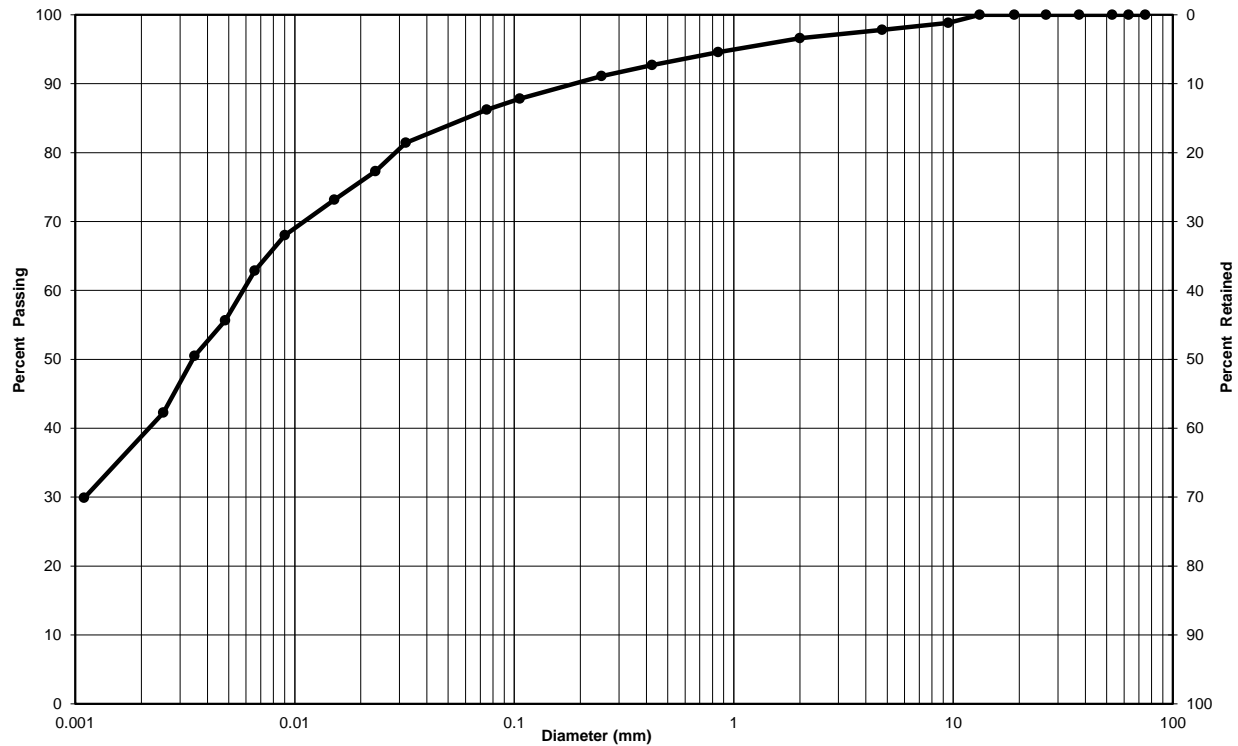
**Borehole No.:** \_\_\_\_\_ **Sample No.:** 3A

Soil Description	Gravel (%)	Sand (%)	Clay & Silt (%)
Lean clay (CL)	2	12	86
Clay-size particles (<0.002 mm):			38 %

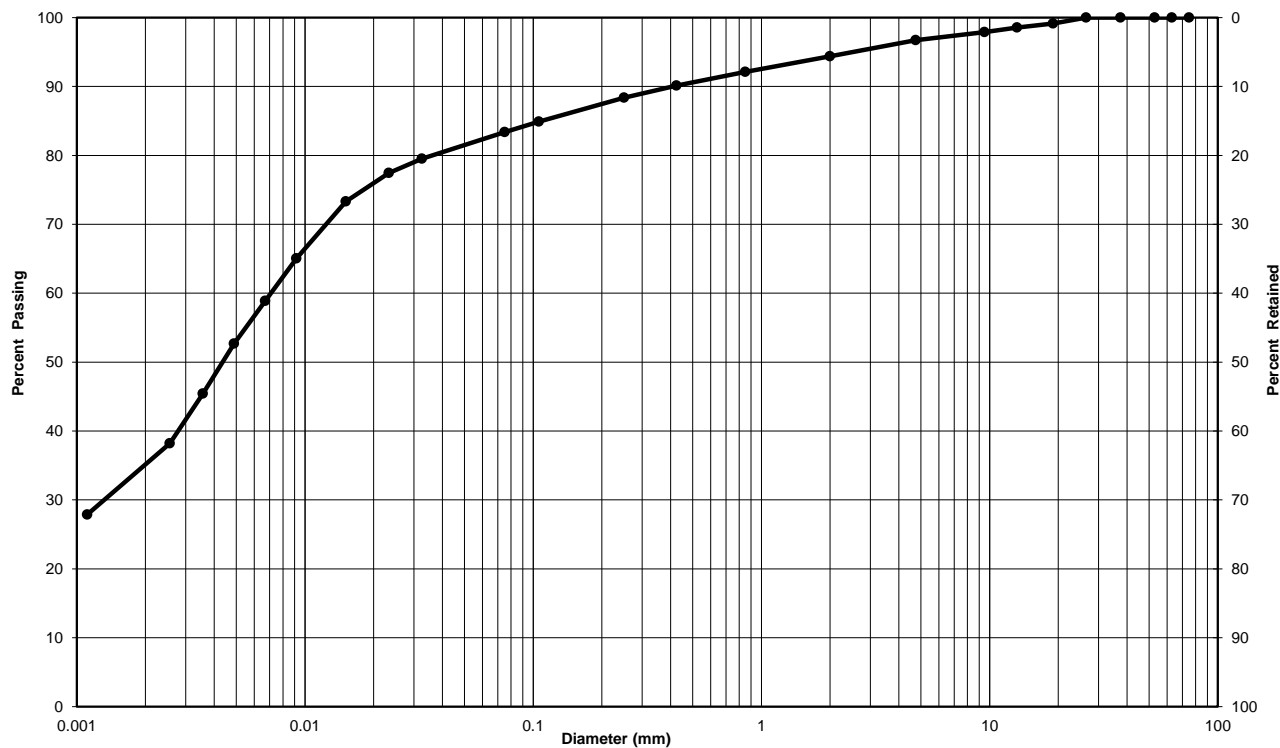
Borehole No.: _____	Sample No.: <u>4A</u>
Depth: _____	Enclosure: <u>-</u>

Soil Description	Gravel (%)	Sand (%)	Clay & Silt (%)
Lean clay with sand (CL)	3	14	83
Clay-size particles (<0.002 mm):	34 %

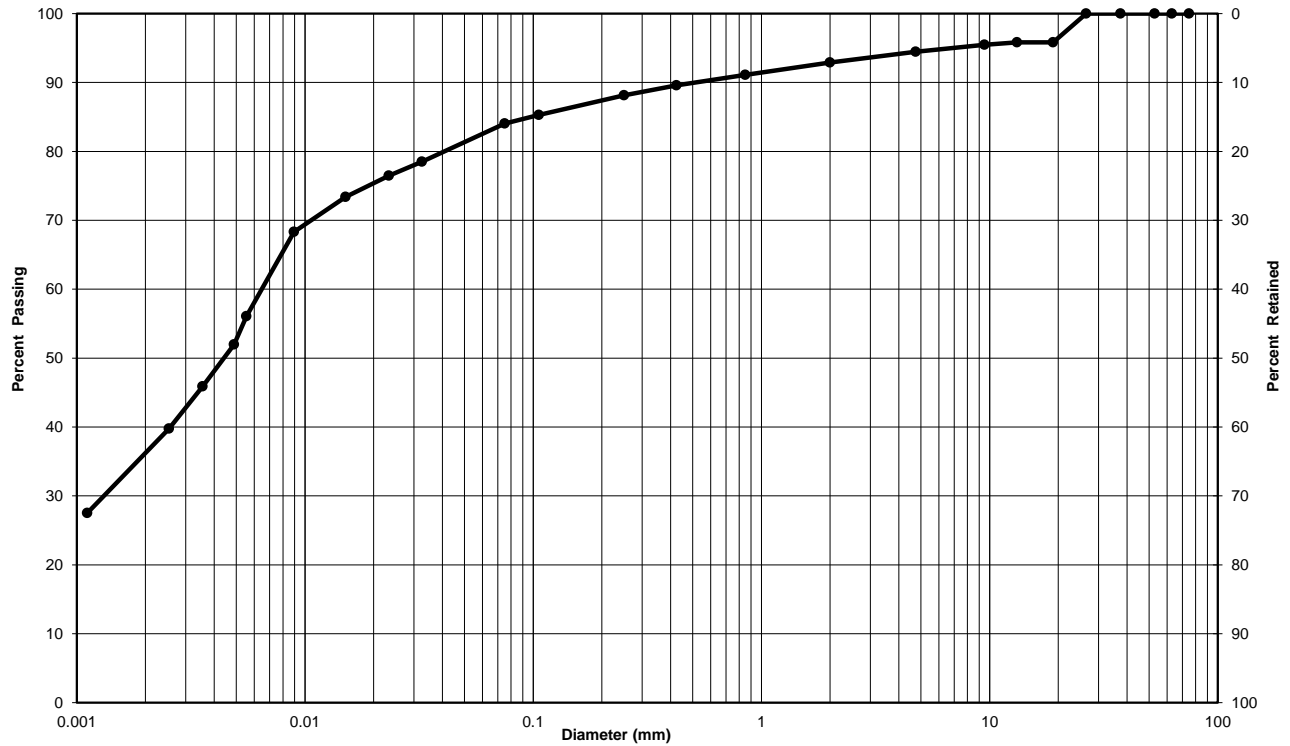
**Borehole No.:** \_\_\_\_\_ **Sample No.:** 5A  
**Depth:** \_\_\_\_\_ **Enclosure:** -

Soil Description	Gravel (%)	Sand (%)	Clay & Silt (%)
Lean clay with sand (CL)	6	10	84
Clay-size particles (<0.002 mm):			35 %

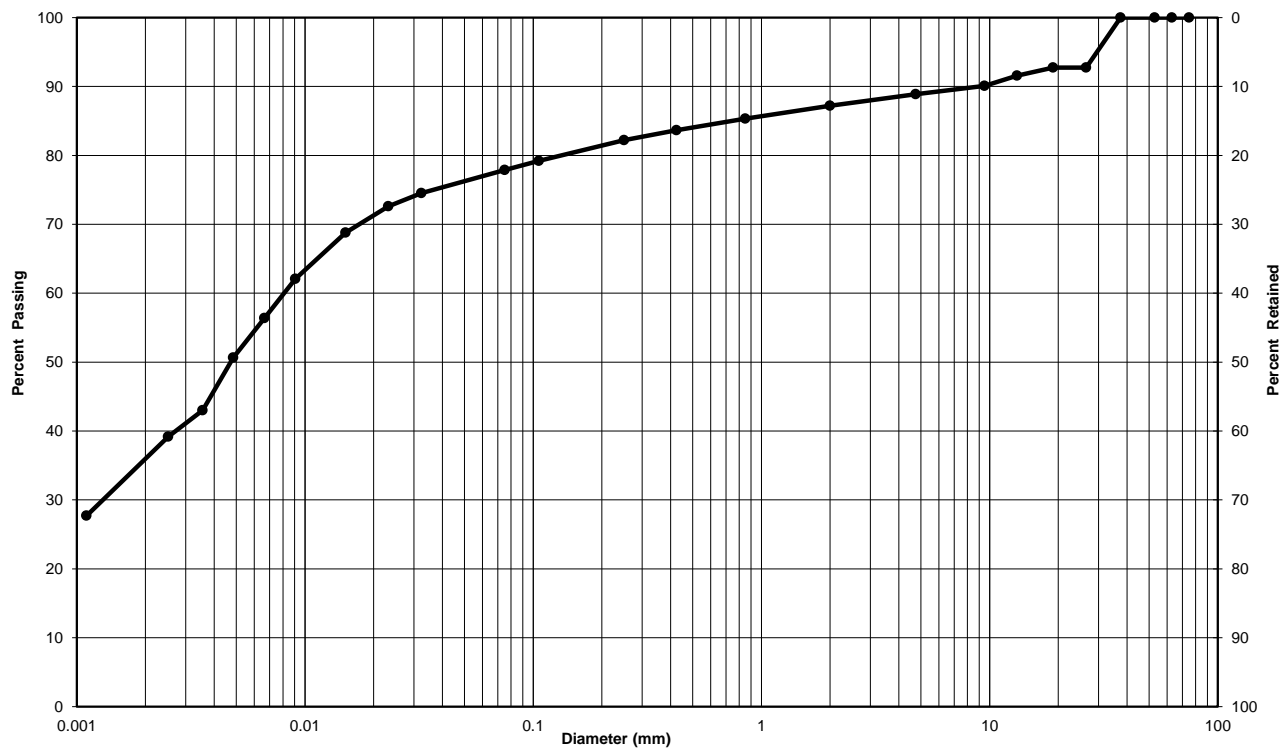
Borehole No.: _____	Sample No.: <u>6A</u>
Depth: _____	Enclosure: <u>-</u>

Soil Description	Gravel (%)	Sand (%)	Clay & Silt (%)
Lean clay with sand (CL)	11	11	78
Clay-size particles (<0.002 mm):			35 %

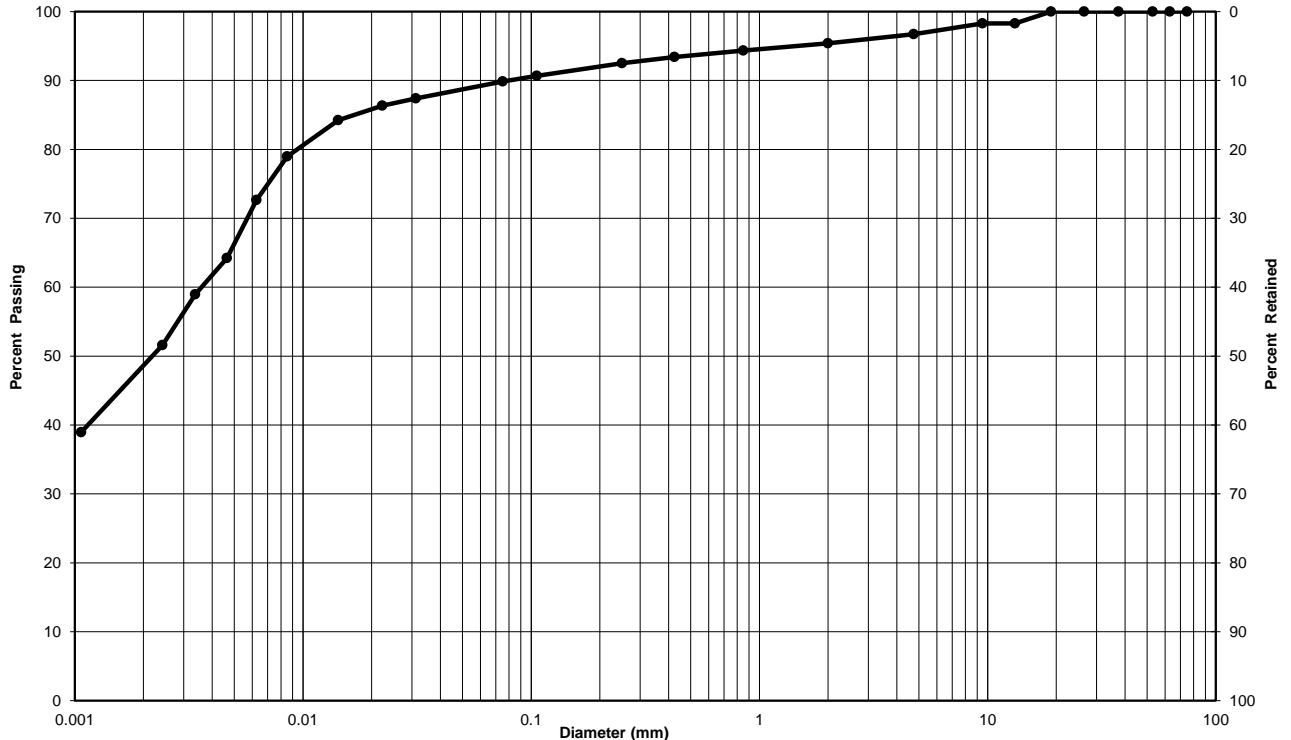
**Borehole No.:** \_\_\_\_\_ **Sample No.:** 7A  
**Depth:** \_\_\_\_\_ **Enclosure:** -

Soil Description	Gravel (%)	Sand (%)	Clay & Silt (%)
Lean clay (CL)	3	7	90
Clay-size particles (<0.002 mm):			48 %

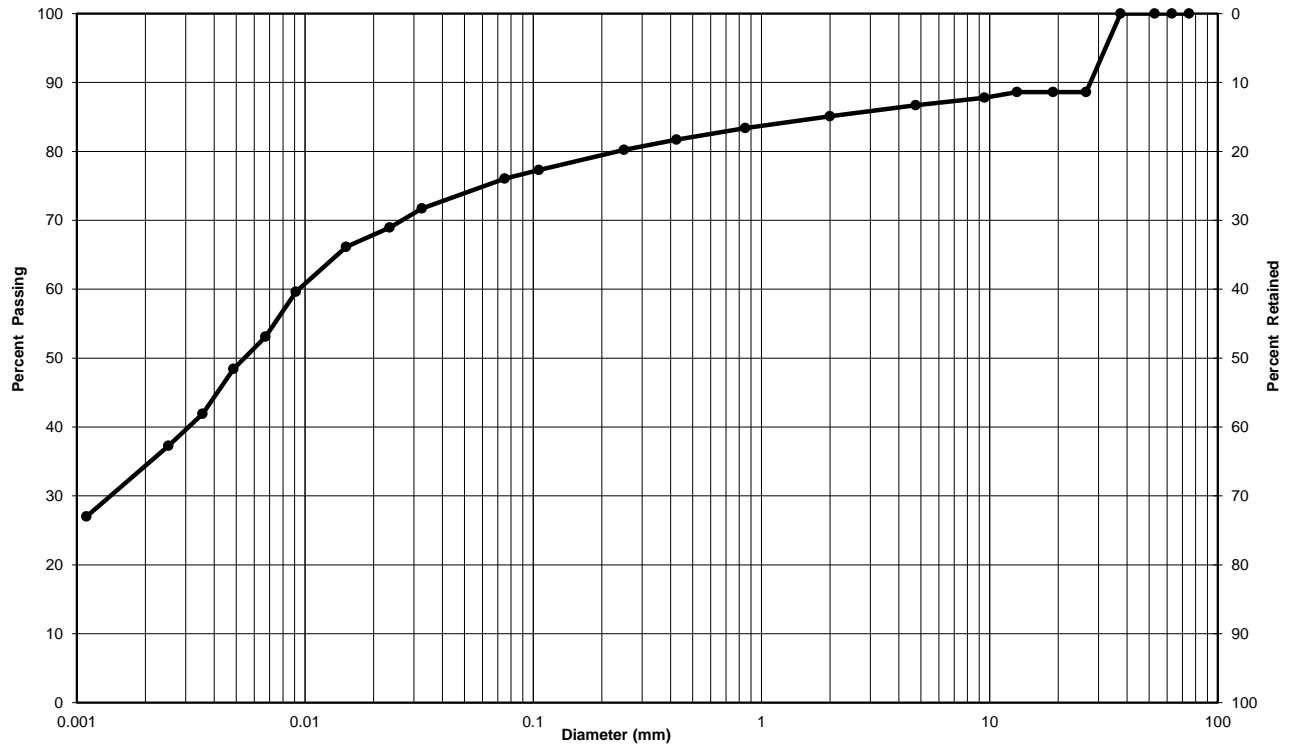
**Borehole No.:** \_\_\_\_\_ **Sample No.:** 8A  
**Depth:** \_\_\_\_\_ **Enclosure:** -

Soil Description	Gravel (%)	Sand (%)	Clay & Silt (%)
Lean clay with gravel (CL)	13	11	76
Clay-size particles (<0.002 mm):			33 %

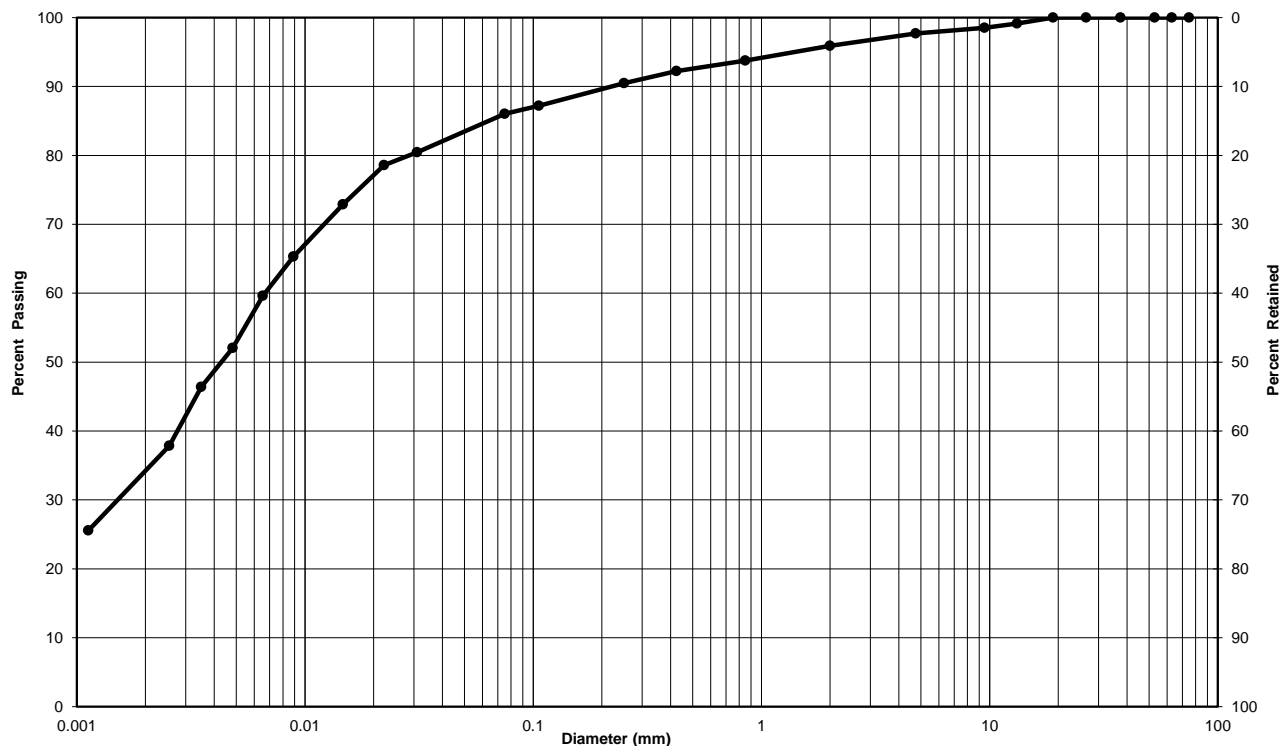
**Borehole No.:** \_\_\_\_\_ **Sample No.:** 9A  
**Depth:** \_\_\_\_\_ **Enclosure:** -

Soil Description	Gravel (%)	Sand (%)	Clay & Silt (%)
Lean clay (CL)	2	12	86
Clay-size particles (<0.002 mm):			33 %
