2017 Construction Inspection Report - Phase 8A Base Liner and Leachate Collection System

65 Green Mountain Road West
Stoney Creek, ON

Terrapure Environmental Stoney Creek Landfill

GHD | 455 Phillip Street Waterloo Ontario N2L 3X2 Canada
11103232| Report No 6 | April 24 2018

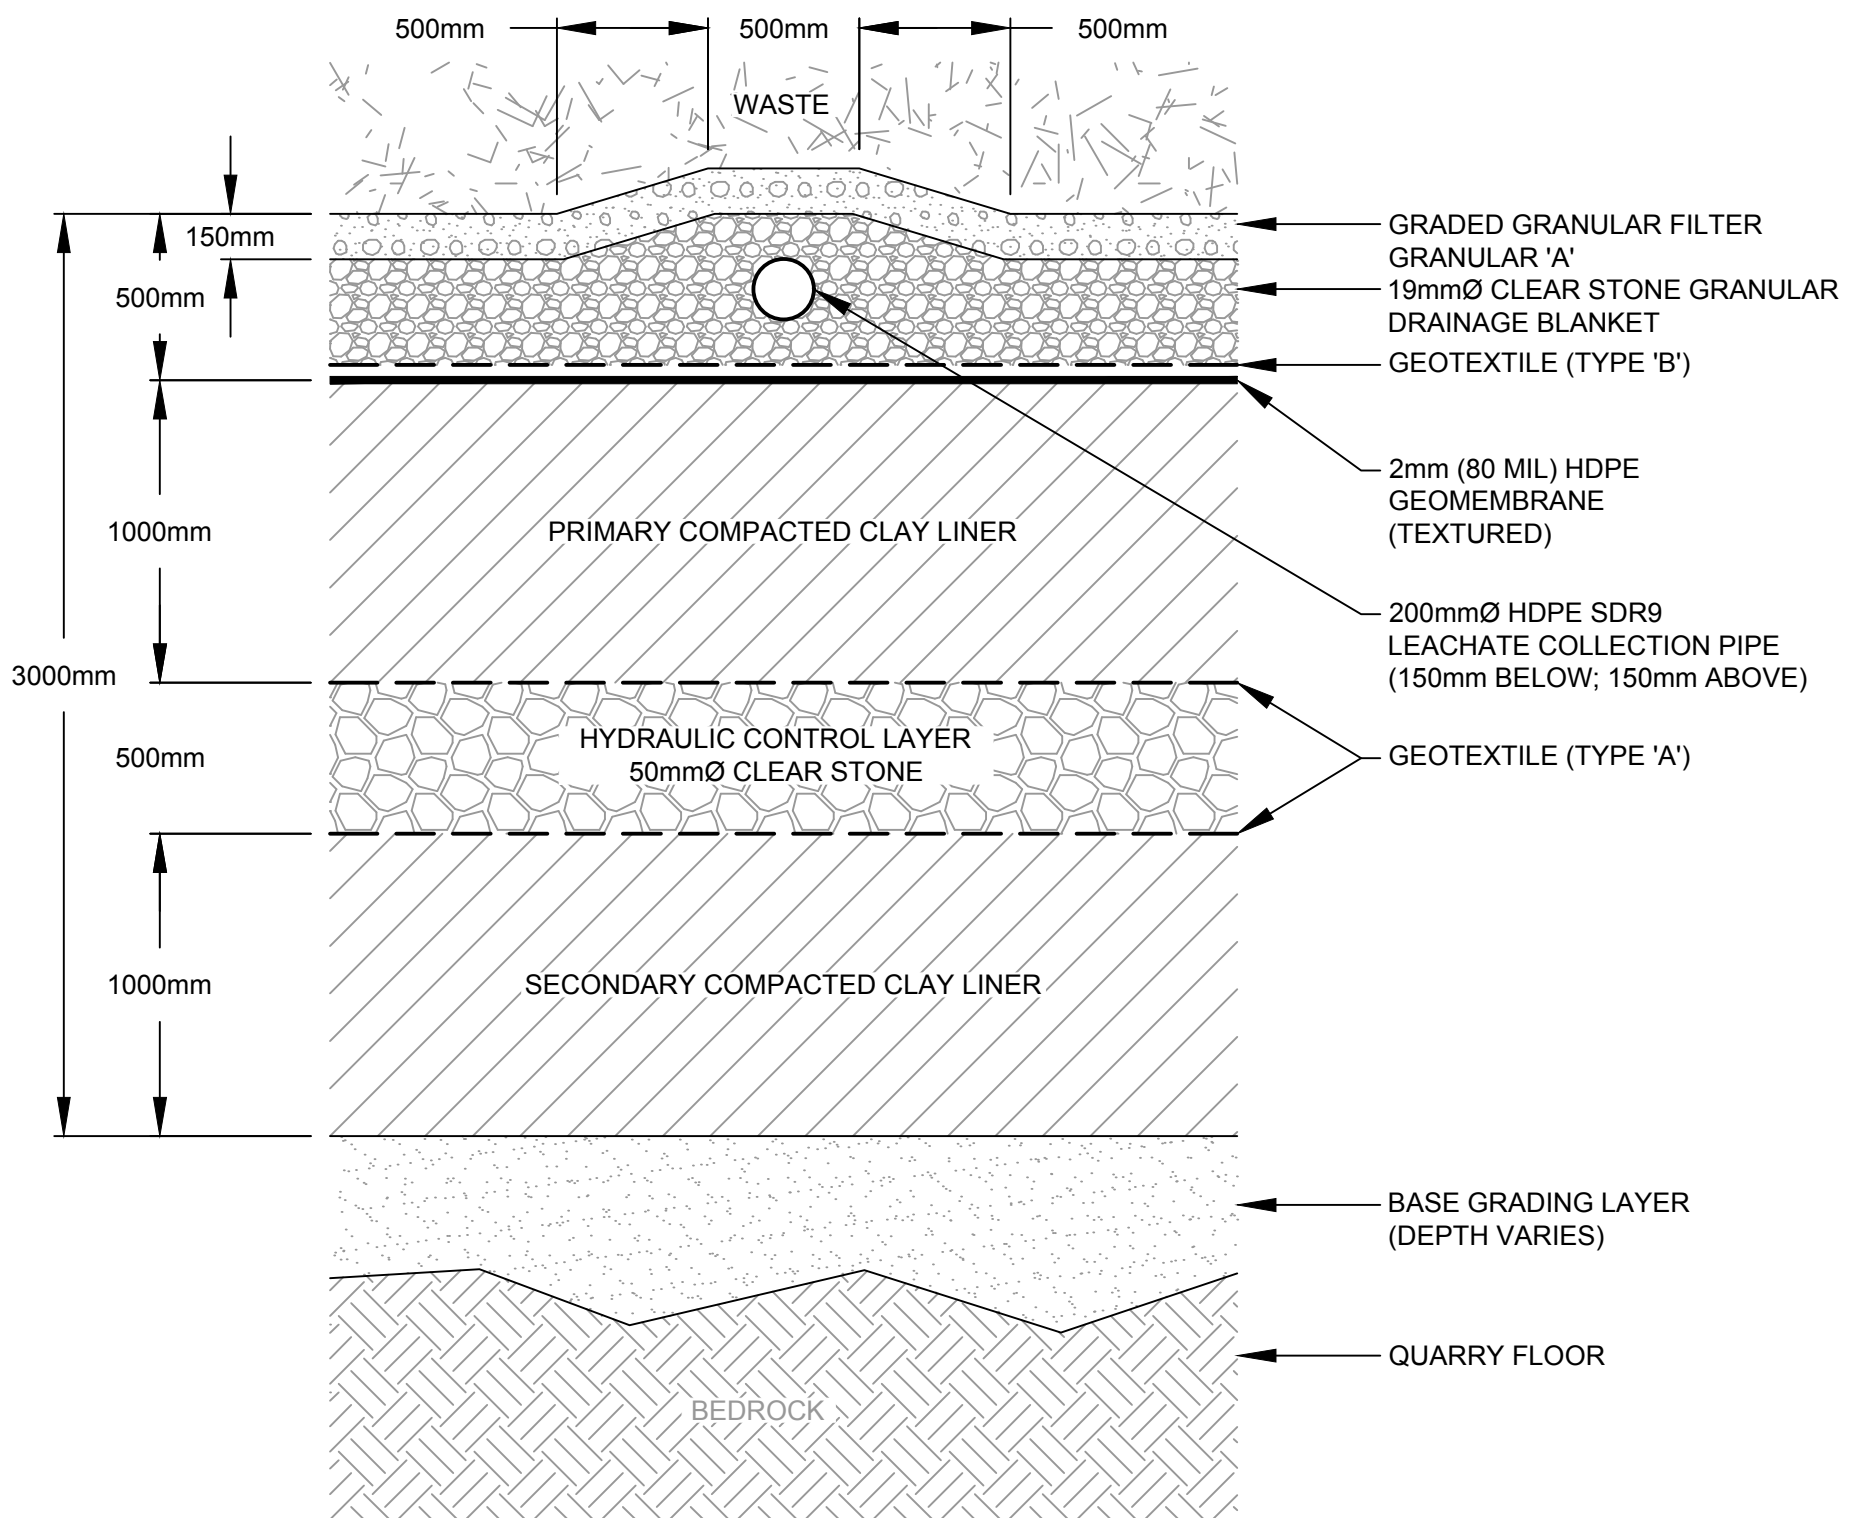
TYPICAL CROSS SECTION THROUGH BASE LINER SYSTEM

The design and development of the SCRF is presented in the site's Design and Operations Report (Gartner Lee, 1995). The base liner and leachate collection system (liner/lcs) is being constructed in phases over the site's operating period. The layout of the phases and a typical cross-section through the liner/lcs are shown in Figures 1 and 2, respectively. As of the end of the 2017 construction season, the liner/lcs has been constructed in Phases 1 through 8A. Construction quality assurance work undertaken for these phases has been documented in previous reports (refer to Section 6 of this report – References).
